Motor Vehicle Forensic Analysis Report

People of the State of New York v.
Nauman Hussain

REFERENCED INVOLVED SUBJECT VEHICLE: 2001 Ford Excursion Stretch Limousine,
VIN 1FMNU40S51EB10299

DATE OF CRASH: October 6, 2018 @ 1355 Hours

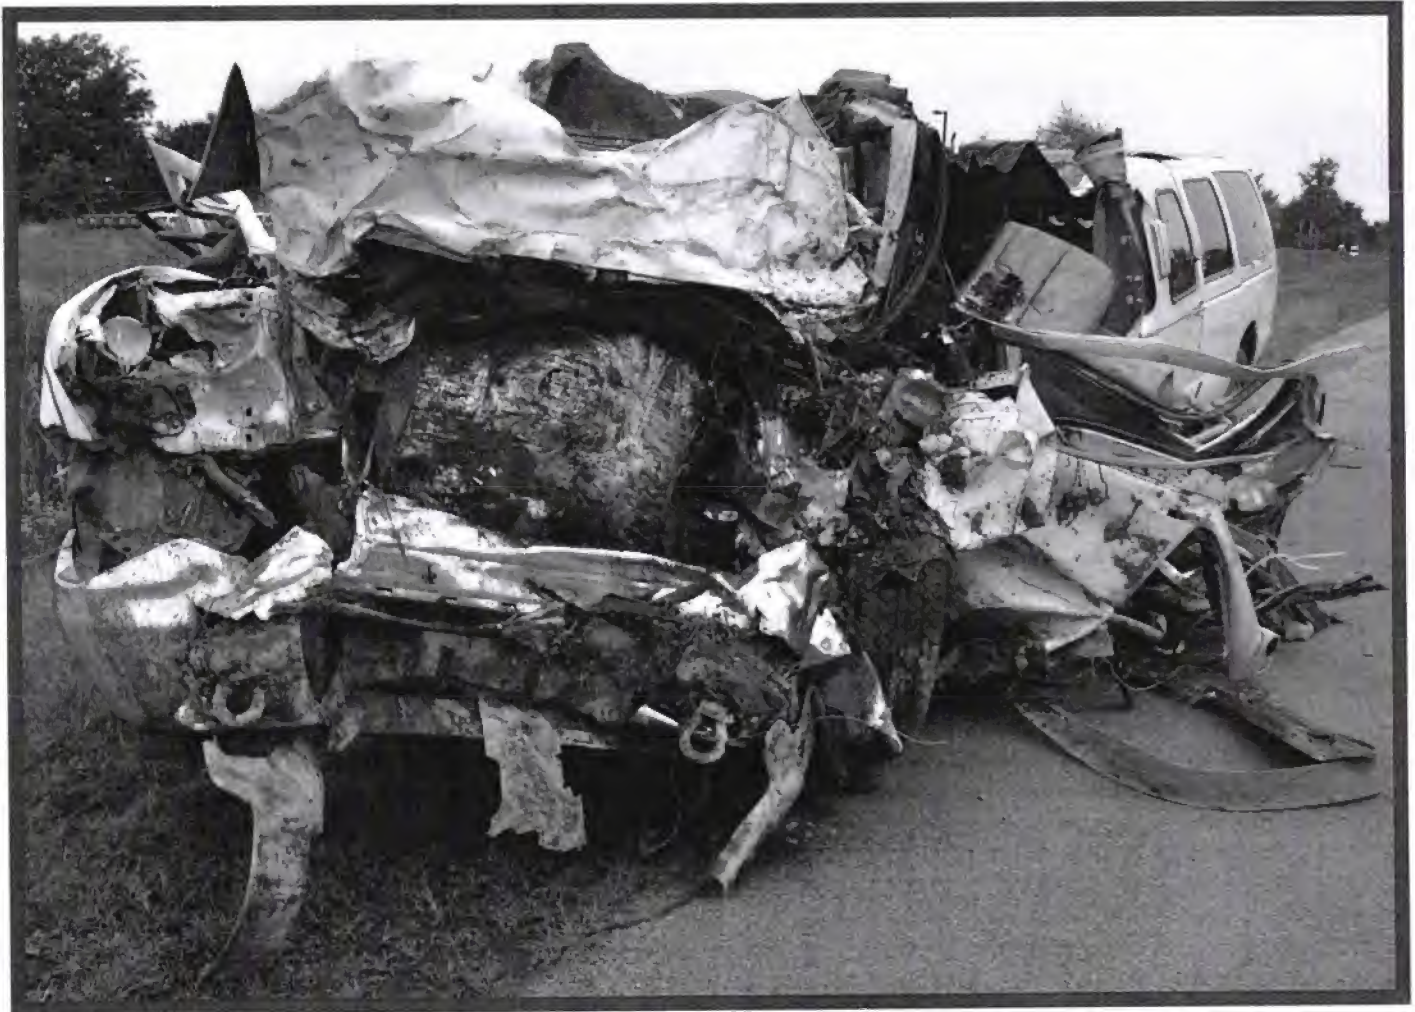
Due to the violent energy forces realized by the 2001 Ford Excursion stretch limousine attributable to the extraordinary level of kinetic energy based upon the mass of the vehicle and extreme velocity at impact, remarkable frontal contact, induced, and structural damage was sustained by the vehicle. These crash related deficiencies were inclusive of frontal frame side sway, frontal frame mash, and frontal frame twist. The extent of the impact structural damage resulted in notable displacement of the engine and transmission.

Image No.4. This photograph depicts the severity of the frontal structural damage sustained by the 2001 Ford Excursion stretch limousine due to the violent impact forces of the crash. Note that the structural integrity of the vehicle rearward of the B-Pillar -- that of the area of "stretch" alteration -- remains intact.

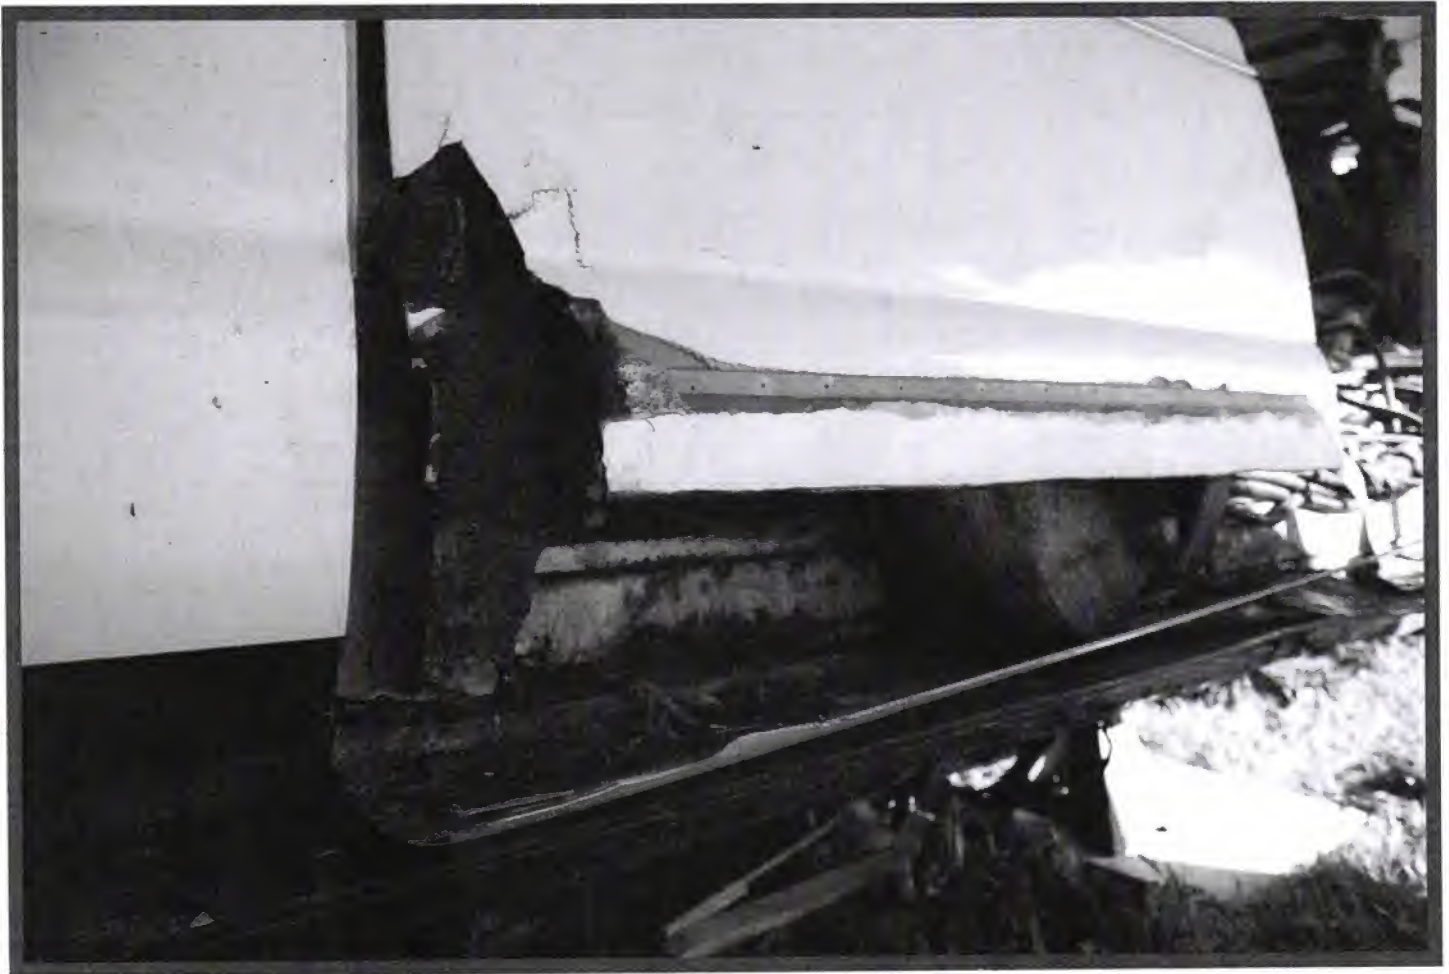
Image No.6. This photograph depicts an area of rust-through, located at the right lower side of the 2001 Ford Excursion stretch limousine. This deficiency, which obviously creates a reduction in the integrity of the body panel, as well as allowing for exhaust gases to enter the passenger compartment of the vehicle, also reflects that of sustained neglect of mandated vehicle maintenance.

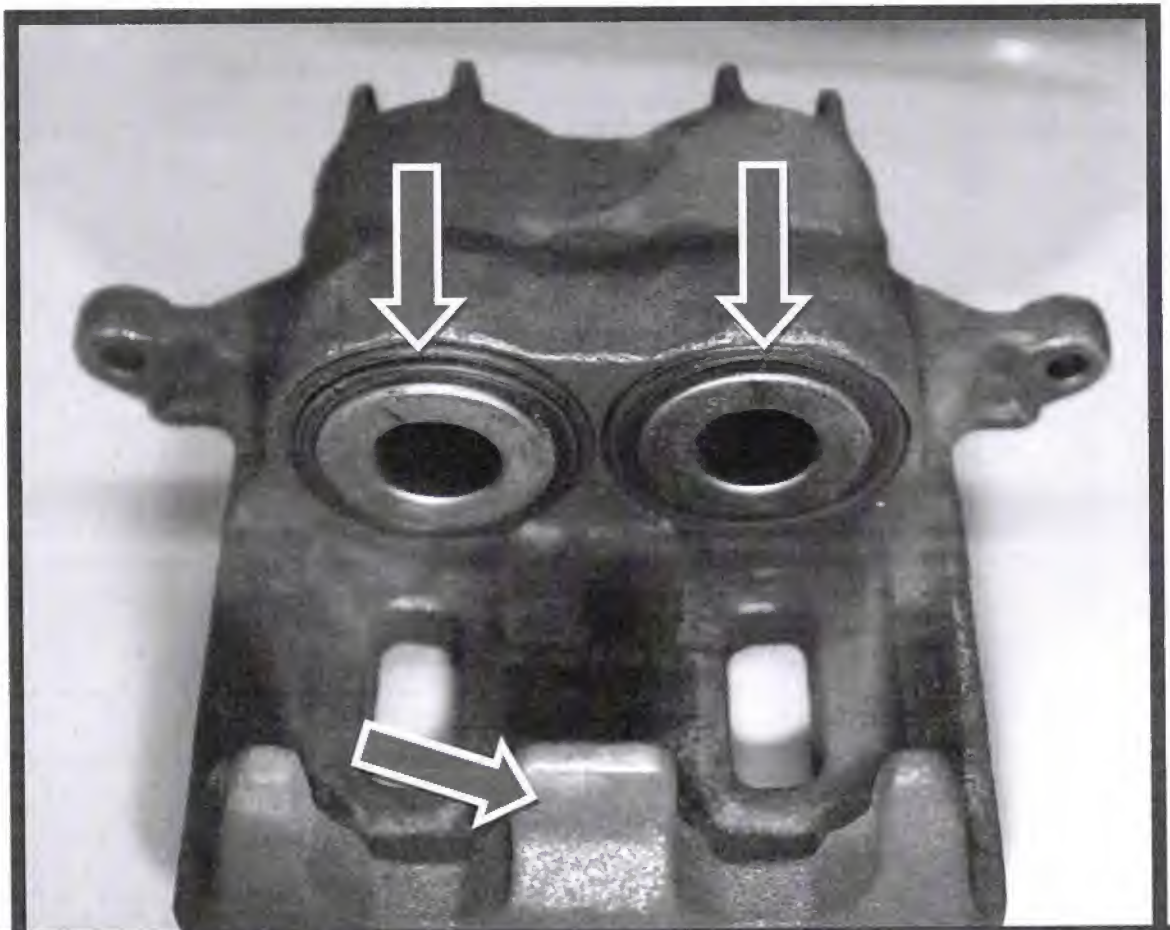
Disc Brake Caliper, Left Rear – The left rear disc brake caliper of the 2001 Ford Excursion stretch limousine exhibited slight casting oxidation, with both piston surfaces presenting insignificant exposure. This condition was consistent with the Repair Order of Mavis Discount Tire dated May 11, 2018¹¹, which indicated replacement of the Brake Caliper, Brake Hose, and Brake Pads. Brake dust presence was nearly nonexistent.

Image No.15. This photograph depicts the left rear disc brake caliper of the involved 2001 Ford Excursion stretch limousine during the period of individual component analysis. Note the state of the cast caliper body, as well as that of the two caliper pistons and piston seals (Blue Arrows). The condition of the component was consistent with that of replacement per the Repair Order of Mavis Discount Tire, dated May 11, 2018.

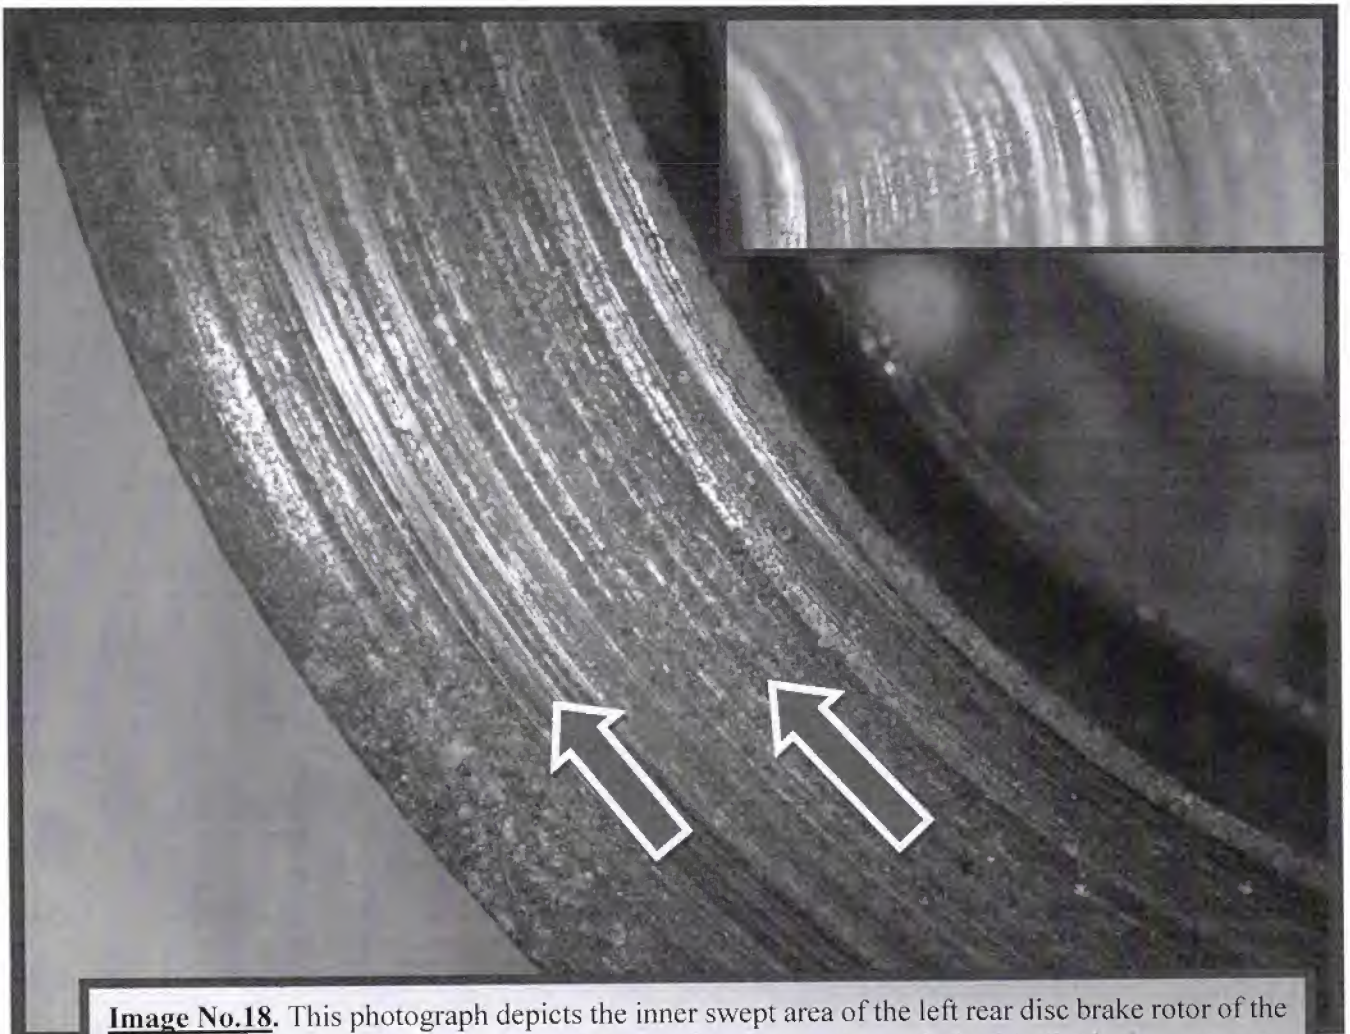
Image No.18. This photograph depicts the inner swept area of the left rear disc brake rotor of the involved 2001 Ford Excursion stretch limousine during the period of individual component analysis. Note the heavy corrosion/scaling and prominent scoring (grooving) present (Red Arrows), consistent with 1)the prolonged operation of vehicle with grossly deteriorated inner brake pad friction material; and 2)ineffective brake effort. Insert photograph depicts the extent of the corrosion/scoring. Photograph below denotes comparison of rotor thickness to that of new rotor.

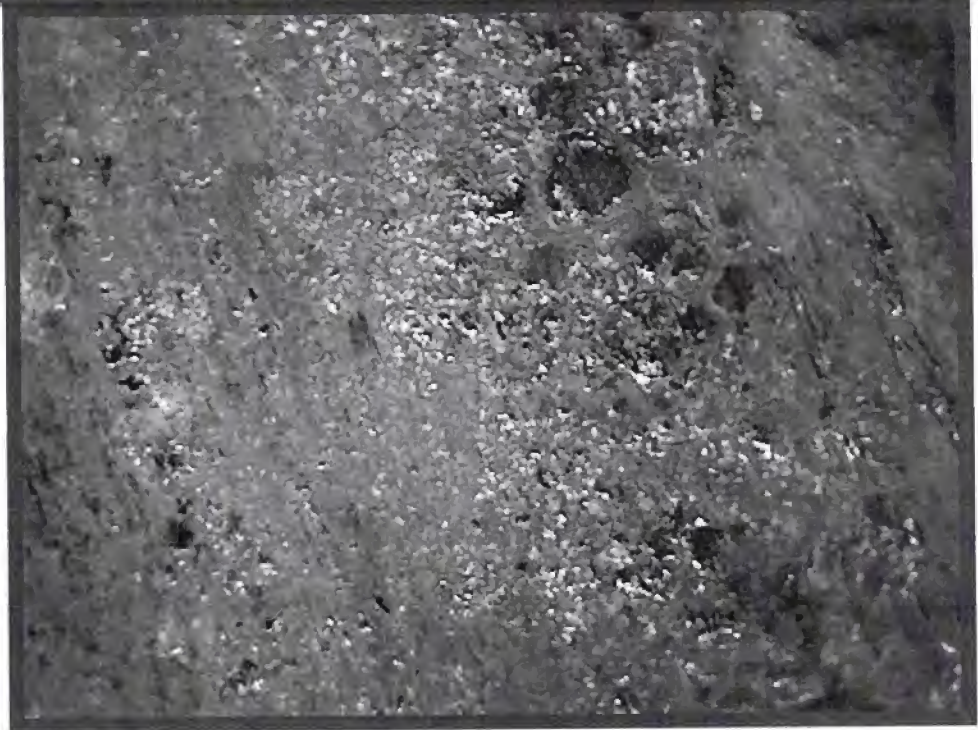
Images No.19a & 19b. These digital microscope photographs depict the critical state of corrosion/delamination present at the inner swept area of the left rear disc brake rotor of the involved 2001 Ford Excursion stretch limousine (above photograph), as well as the oxidation/corrosion present at the outer disk brake rotor swept area (bottom photograph).

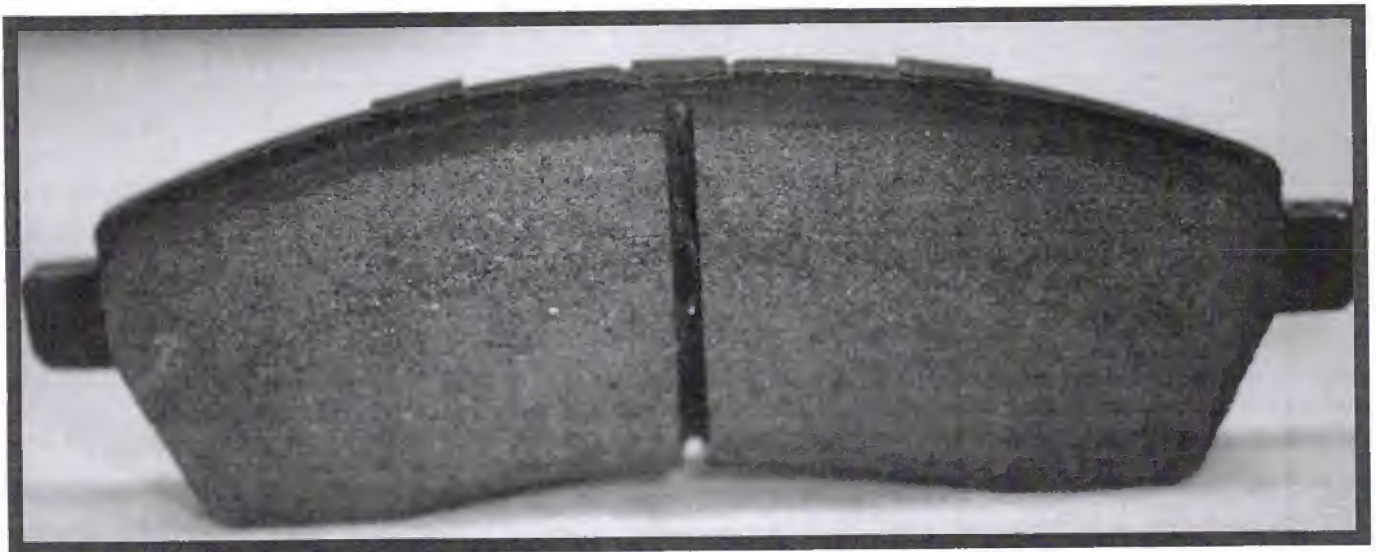
- ✓ Digital measurements of friction material thicknesses of inner and outer disc brake pads exhibited minimal discrepancies compared to digital measurements of new disc brake pads purchased for comparison, despite replacement by Mavis Discount Tire on May 11, 2018.
- ✓ Bonded design disc brake pads, semi-metallic composition.
- ✓ Brake dust presence nearly nonexistent.
- ✓ No thermal distress noted.
- ✓ Original black steel foundation plate paint clearly evident.
- ✓ Inner disc brake pad friction material exhibited embedded corrosion deposits, with no evidence of scoring wear from severely scored inner left rear disc brake rotor swept area.

Images No.20a & 20b. These photographs depict the outer disc brake pad (above photograph) and inner disc brake pad (bottom photograph) of the involved 2001 Ford Excursion stretch limousine. Note the obvious "as new" appearance inclusive of intact original black paint and absence of inner disc brake pad friction material striations resulting from brake force at scored inner disc brake rotor swept area.

Summary of Forensic Analysis, Left Rear Brake System Components¹²: Pre-existing state was that of operational, albeit with reduced brake effort due to acute corrosion, delamination, and scoring present at disc brake rotor swept area contact locations of disc brake pad friction material. Analysis of wear characteristics of left rear brake components further consistent with reduced hydraulic brake force at left rear wheel location of involved 2001 Ford Excursion stretch limousine. Condition was pre-existing, as supported by the notable absence of obvious brake dust at locations inclusive of the left rear alloy wheel.

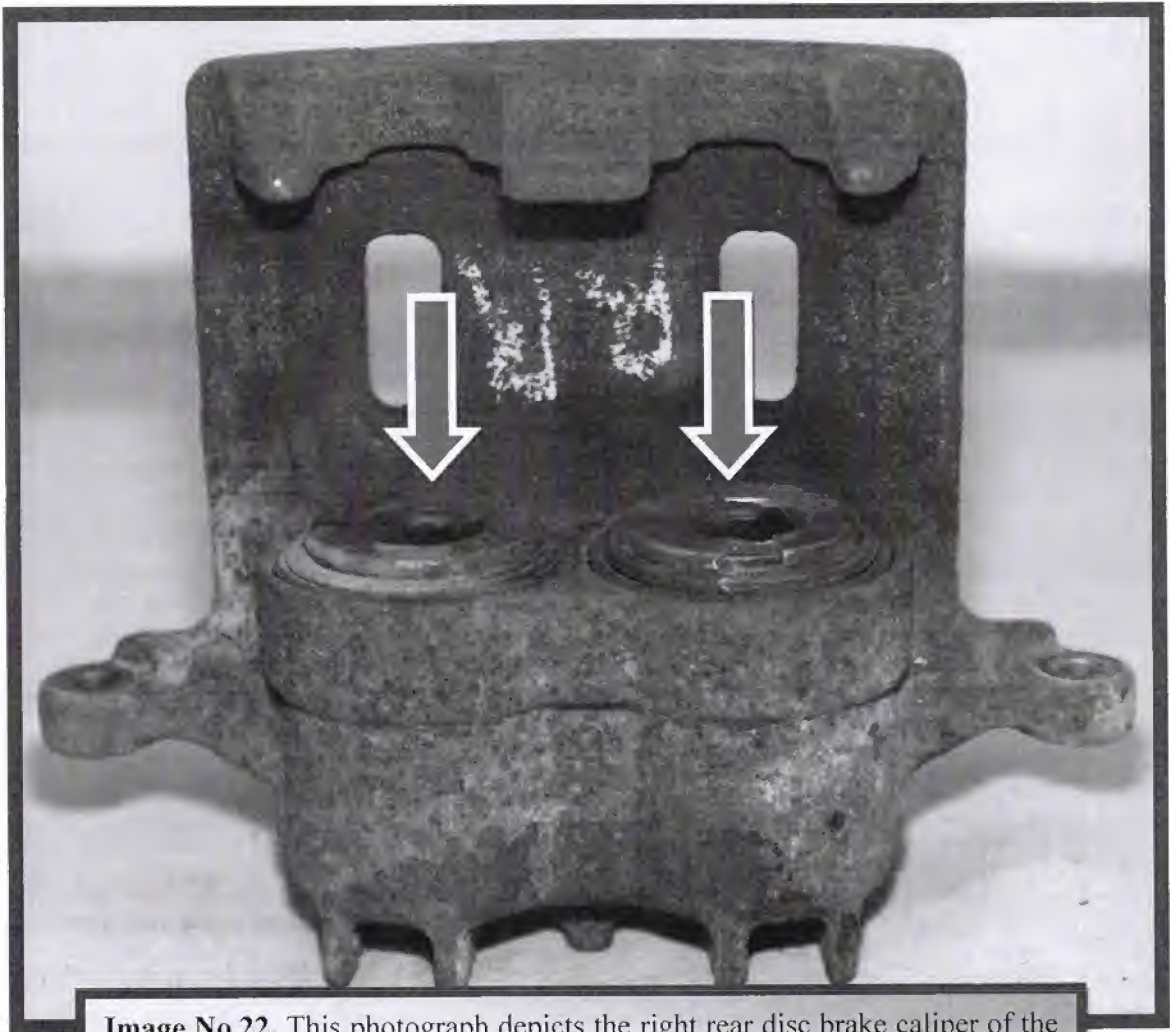
Disc Brake Caliper, Right Rear – The right rear disc brake caliper of the 2001 Ford Excursion stretch limousine exhibited prominent casting corrosion; corrosion/pitting at the outer disc brake pad flange; and remarkable corrosion at the bleeder valve area. The two brake caliper pistons were seized within the respective caliper housing bores, rendering brake force nonexistent at the right rear wheel location. This condition was pre-existing.

Image No.22. This photograph depicts the right rear disc brake caliper of the involved 2001 Ford Excursion stretch limousine prior to removal from the vehicle. Note the prominent corrosion -- the caliper was that of an older design, with steel composition pistons as opposed to phenolic pistons. The two caliper pistons were seized within their respective bores of the caliper body (Blue Arrows) -- a pre-existing condition.

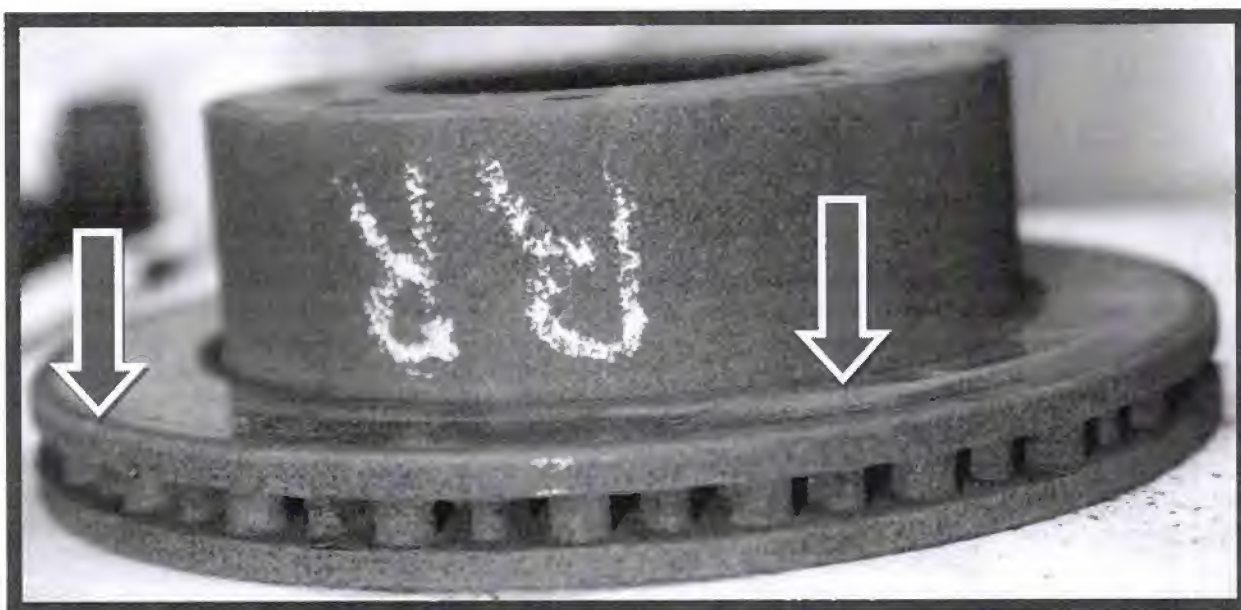
Disc Brake Rotor, Right Rear – The examination and forensic analysis of the right rear disc brake rotor of the 2001 Ford Excursion stretch limousine revealed that of a heavy duty, eight (8) stud hole, cast disc brake rotor. The right rear disc brake rotor exhibited evidence of pre-existing inoperable brake effort at the right rear wheel location of the 2001 Ford Excursion stretch limousine, including negligible brake friction wear conditions despite alleged 2016 replacement and oxidation/corrosion of inner/outer swept areas.

- ✓ No thermal distress noted.
- ✓ Minimal brake dust presence.
- ✓ Outer swept area exhibited corrosion, oxidation, pitting, and scoring.
- ✓ Inner swept area exhibited corrosion, pitting, and scoring.
- ✓ Condition consistent with deficiencies in effective brake effort.
- ✓ Disc brake rotor was not machined/replaced during brake service conducted by Mavis Discount Tire on May 11, 2018.
- ✓ Minimum measured right rear disc brake rotor thickness = 1.183". Original disc brake rotor thickness = 1.185". Minimum disc brake rotor thickness specification = 1.10". Minimum disc brake rotor thickness to machine rotor specification = 1.12".
- ✓ Reduced brake component cooling due to heavy corrosion at cooling fins.

- ✓ Disc brake rotor thickness measurements revealed merely negligible wear from braking, despite alleged rotor replacement on September 10, 2016¹³.
- ✓ Park Brake maximum measured diameter = 8.104". Park Brake maximum diameter specification = 8.157".
- ✓ Disc brake rotor swept area measured parallelism = 0.010". Maximum typical parallelism = 0.0005".
- ✓ Disc brake rotor swept area measured lateral runout = 0.011". Maximum typical lateral runout = 0.0008".

Image No.23. This photograph depicts the right rear disc brake rotor of the involved 2001 Ford Excursion stretch limousine during the period of individual component analysis. Note the oxidation/corrosion present at the outer rotor swept area, as well as absence of wear evidence from braking since replacement in 2016. (Red Arrows), consistent with the previously described condition of pre-existing seized brake caliper pistons which prevented brake application at the right rear wheel location.

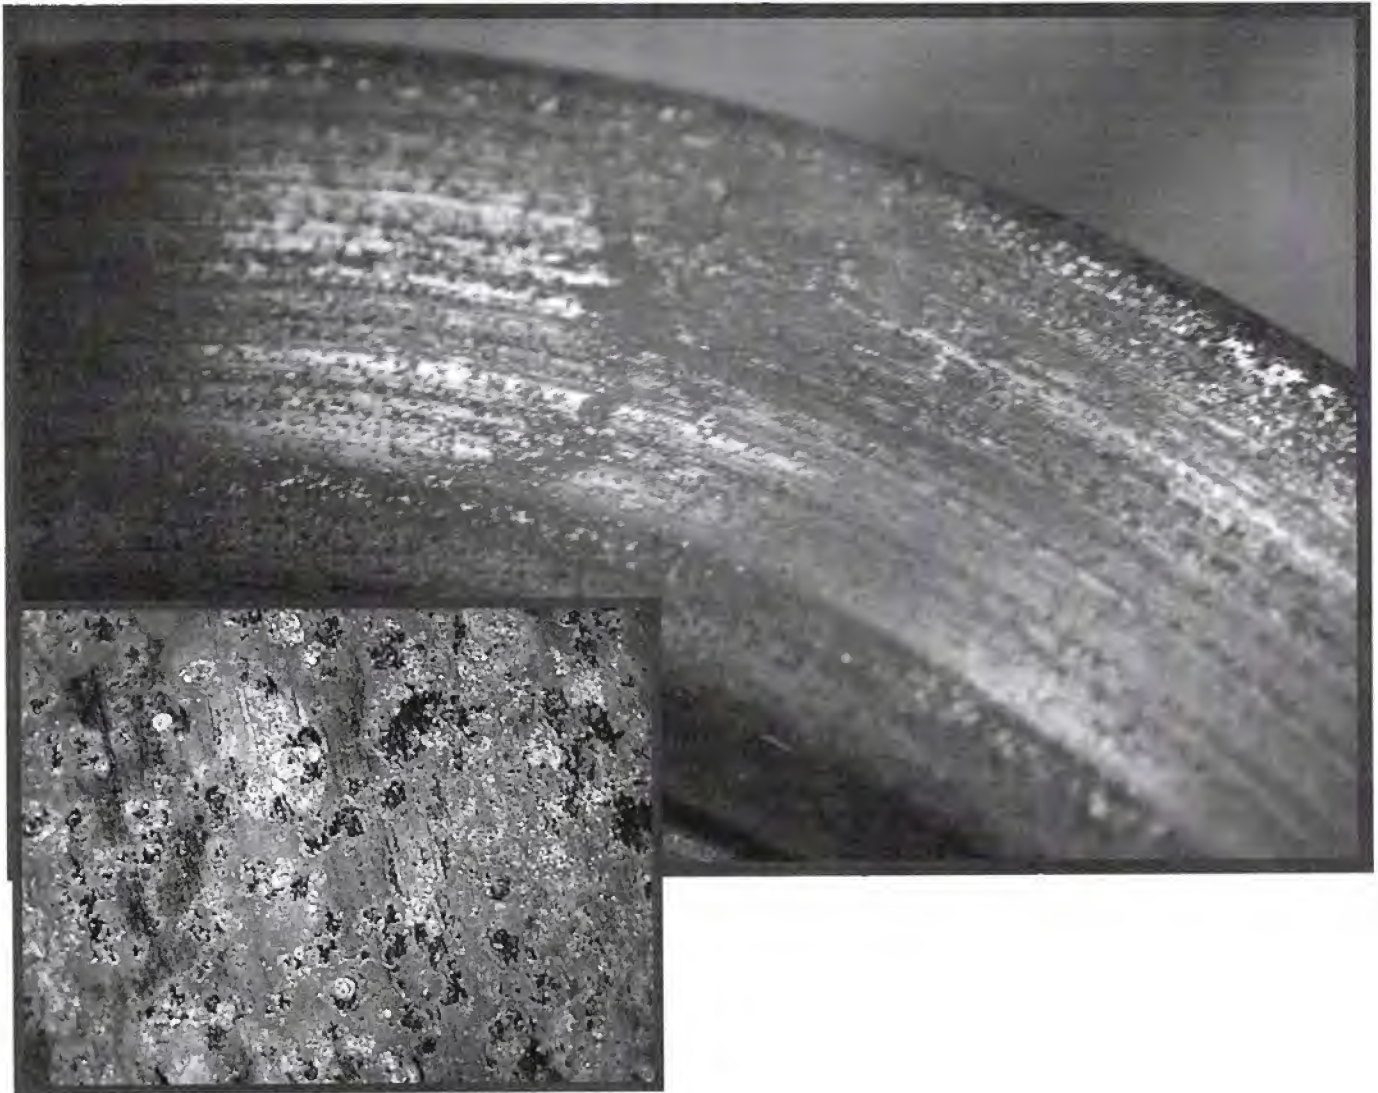
Image No.24. This photograph depicts the inner swept area of the right rear disc brake rotor of the involved 2001 Ford Excursion stretch limousine during the period of individual component analysis. Note the oxidation/corrosion/pitting present within the outer rotor swept area, as well as absence of wear evidence from braking since replacement in 2016, consistent with the previously described condition of pre-existing seized brake caliper pistons which prevented brake application at the right rear wheel location. Insert digital microscope image denotes swept area surface.

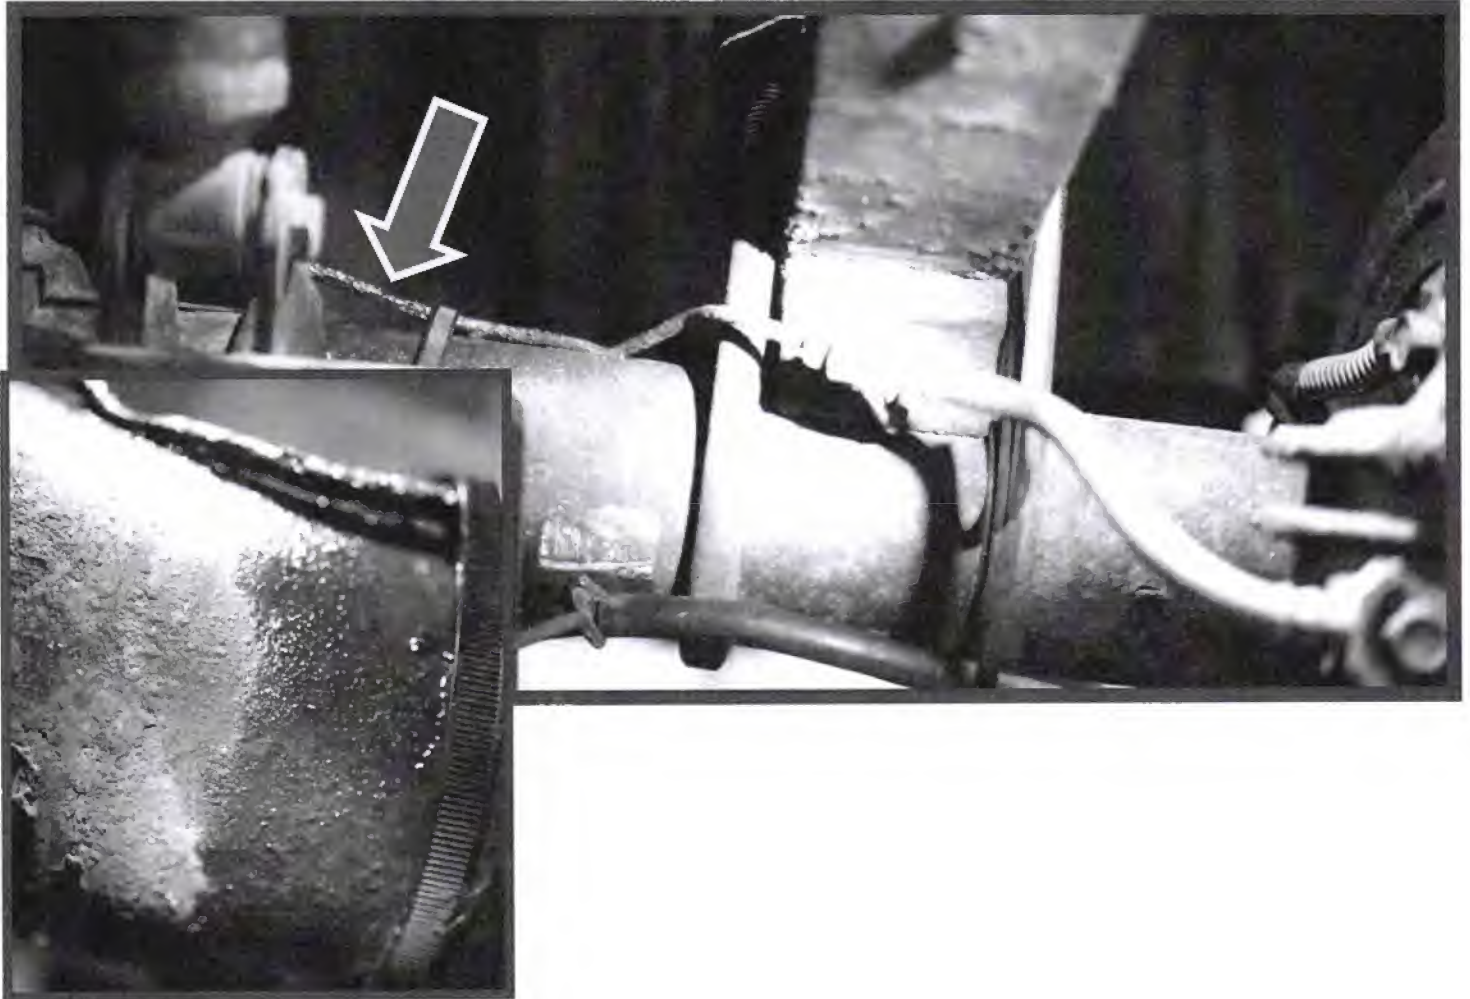
Brake Tubing, Right Rear – The examination of the steel composition, rear crossover brake tubing located on the rear differential housing of the involved 2001 Ford Excursion stretch limousine revealed that the section of tubing had experienced failure of integrity, with resulting loss of brake fluid, due to pre-existing critical tubing corrosion. This loss of integrity is typically associated with considerable brake pedal force executed by the operator of the vehicle.

Due to the mandated split service design of the hydraulic braking system of the 2001 Ford Excursion stretch limousine, this loss of integrity at the right rear crossover brake tubing would result in overall brake failure at both left and right rear wheel locations of the vehicle -- braking of the 2001 Ford Excursion stretch limousine would be totally dependent upon the left and right front brake components only.

Image No.28. This photograph depicts the rear crossover section of brake tubing, at the right rear differential housing axle tube of the 2001 Ford Excursion stretch limousine. The obvious perilous corrosion of the length of steel composition brake tubing resulted in a catastrophic loss of integrity (Red Arrow), with brake fluid loss clearly discernible from the insert photograph. The loss of integrity resulted in no braking action at the left and right rear wheel locations.

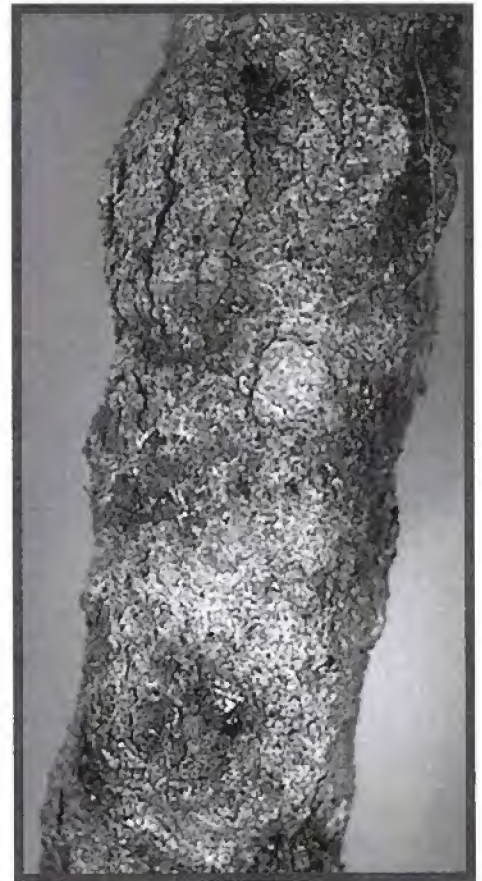
Image No.29. This photograph depicts the rear crossover section of brake tubing, removed from the design location at the right rear differential housing axle tube of the 2001 Ford Excursion stretch limousine. The obvious extent of pre-existing corrosion can be readily denoted, as depicted by the above photograph in the area of the Black Arrow.

The area of the steel composition brake tubing designated as "Crimp" is that of partially collapsed brake tubing, consistent with improper removal of the right rear disc brake caliper of the vehicle.

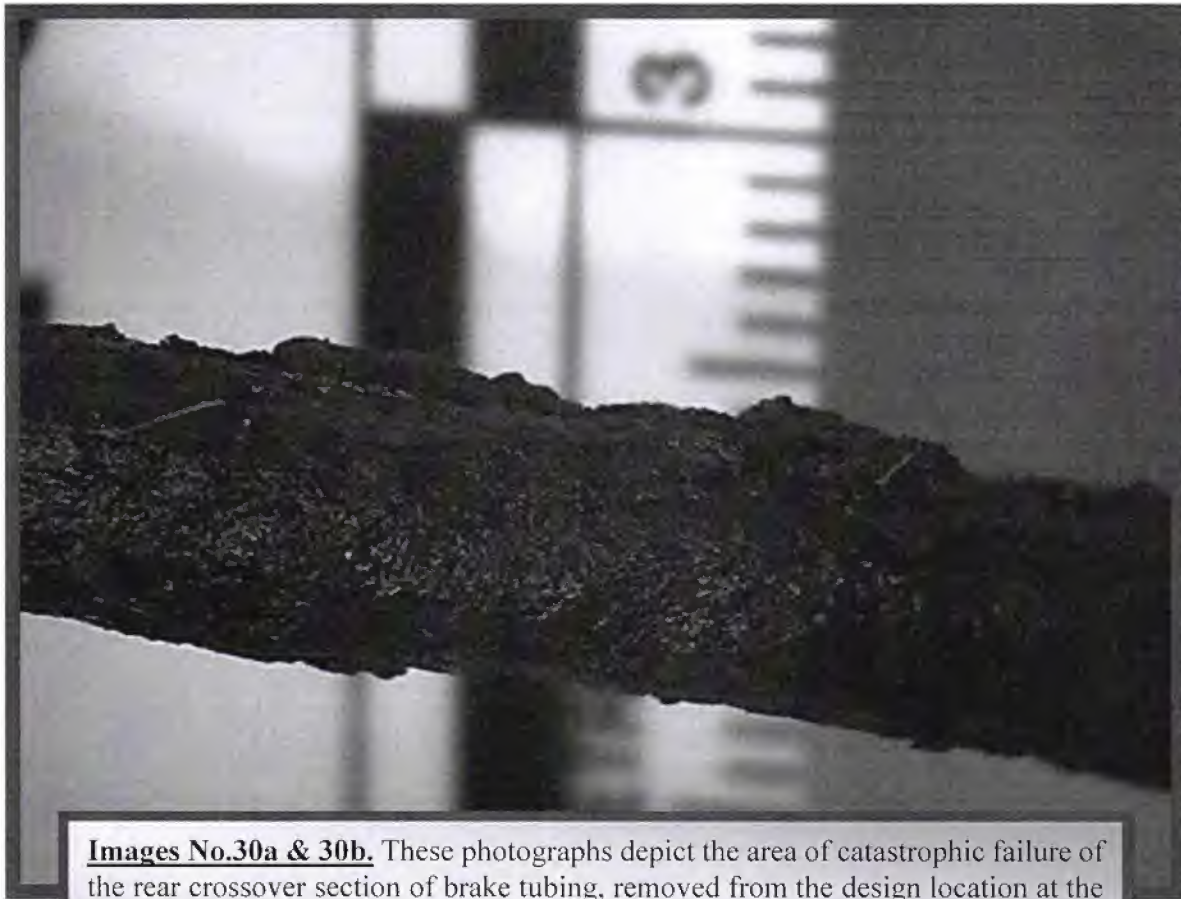
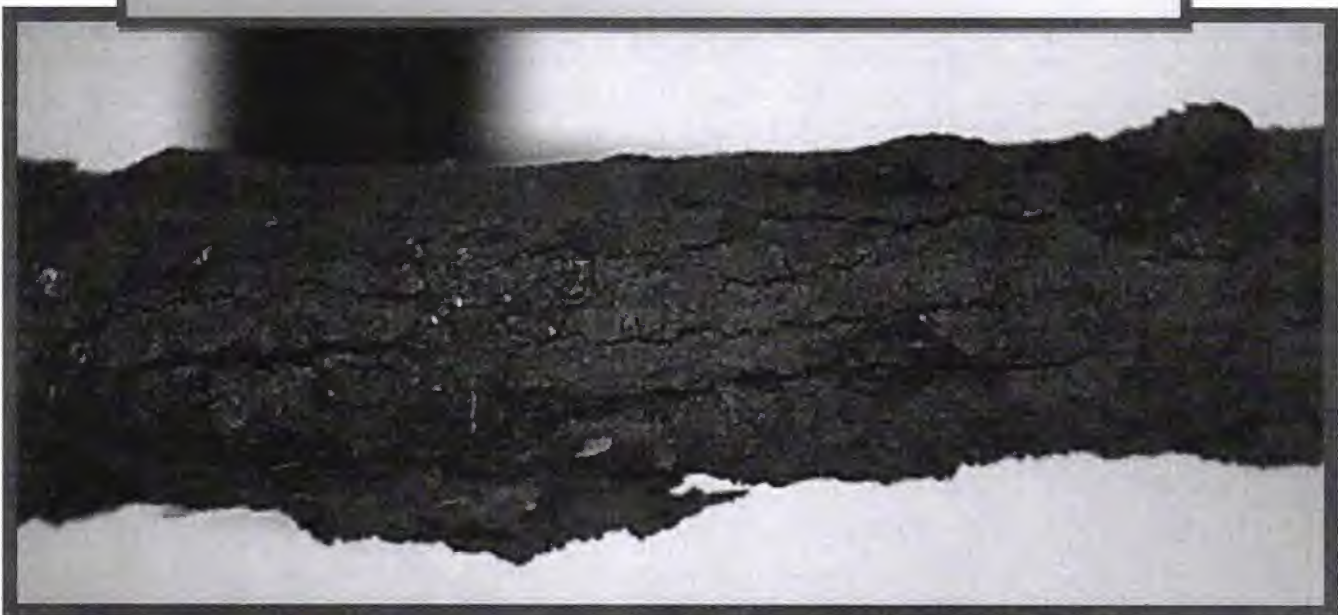
Images No.30a & 30b. These photographs depict the area of catastrophic failure of the rear crossover section of brake tubing, removed from the design location at the right rear differential housing axle tube of the 2001 Ford Excursion stretch limousine. Again, the obvious extent of pre-existing corrosion can be readily denoted.

Summary of Forensic Analysis, Right Rear Brake System Components: *No braking effort whatsoever in effect at the right rear wheel location of the 2001 Ford Excursion stretch limousine. Condition was pre-existing, as supported by forensic evidence and the absence of obvious brake dust at locations inclusive of the right rear alloy wheel.*

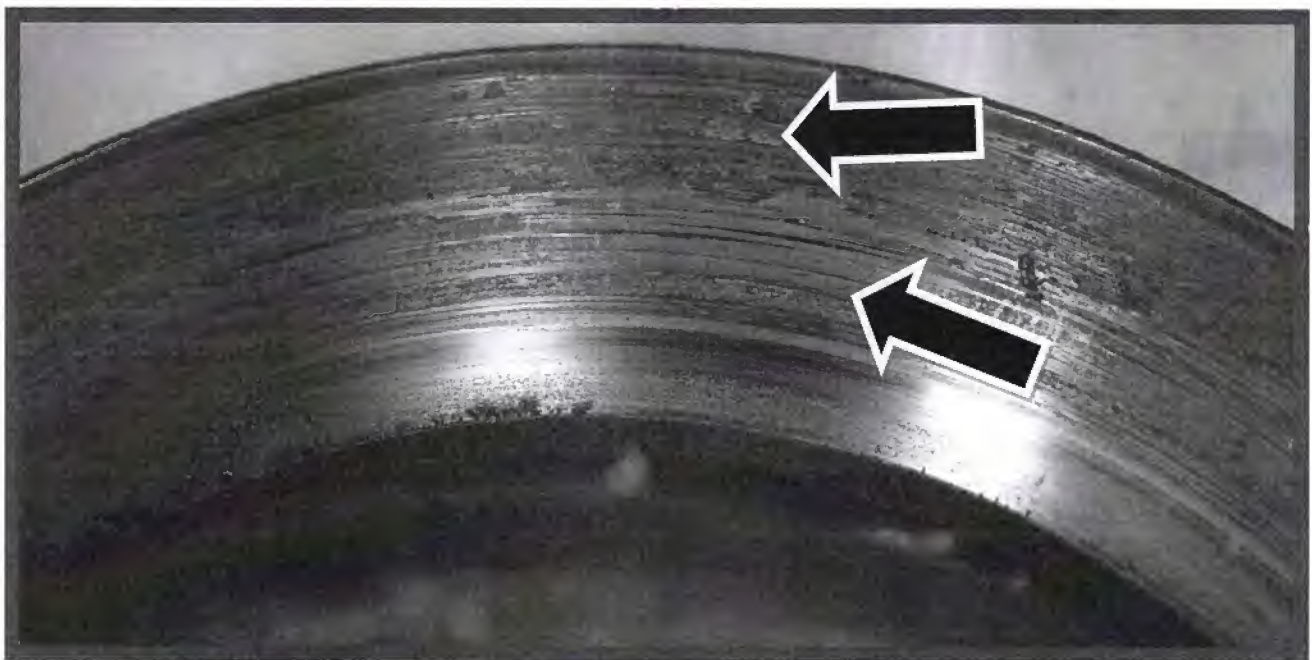
Disc Brake Rotor, Left Front – The examination and forensic analysis of the left front disc brake rotor of the 2001 Ford Excursion stretch limousine revealed that of a two piece, heavy duty, eight (8) stud hole, cast disc brake rotor. The left front disc brake rotor exhibited prominent evidence of thermal distress, with a remarkable odor of burnt materials/components.

- ✓ Outer swept area presented scoring, pitting, corrosion, and embedded brake pad friction material.
- ✓ No brake dust detected due to prior extreme component temperatures.
- ✓ Inner swept area exhibited corrosion, oxidation, pitting, scoring, and embedded brake pad friction material.
- ✓ Condition consistent with extreme thermal distress from brake effort.
- ✓ Rotor vent area exhibited hardened deposits of burnt material.
- ✓ Reduced brake component cooling due to heavy corrosion at cooling fins.
- ✓ Notable scoring, inner bearing race.
- ✓ Minimum measured left front disc brake rotor thickness = 1.502". Minimum disc brake rotor thickness specification = 1.410". Minimum disc brake rotor thickness to machine rotor specification = 1.440".

Image No.32. This photograph depicts the outer swept area of the left front disc brake rotor of the 2001 Ford Excursion stretch limousine during the period of individual component analysis. The effects of severe thermal distress were clearly evident, including embedded material consistent with thermal deterioration of disc brake pad friction material (Black Arrows).

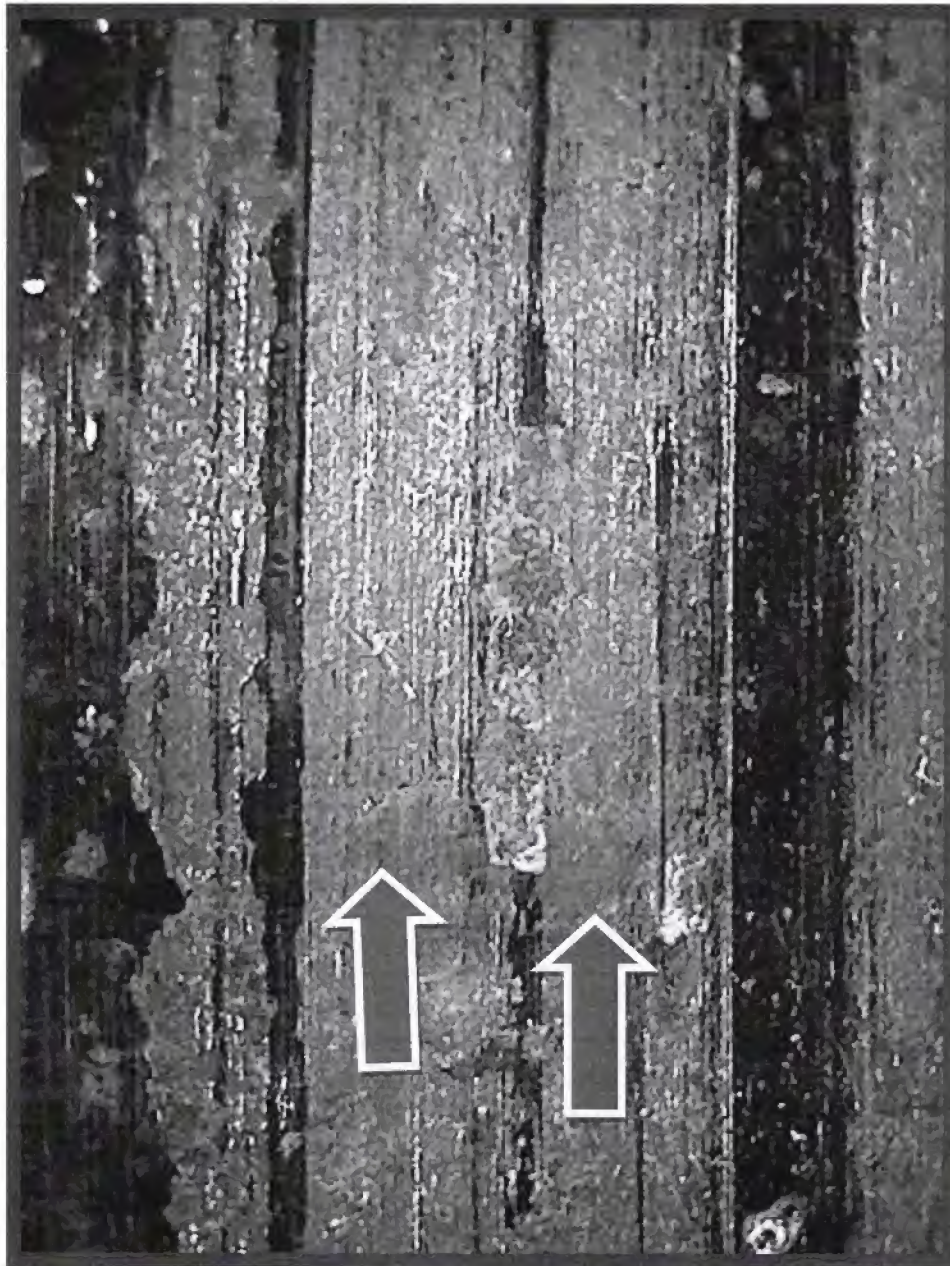
Image No.33. This digital microscope image depicts the inner swept area of the left front disc brake rotor of the 2001 Ford Excursion stretch limousine during the period of individual component analysis. The effects of severe thermal distress were clearly evident, including embedded material consistent with thermal deterioration of disc brake pad friction material (Red Arrows).

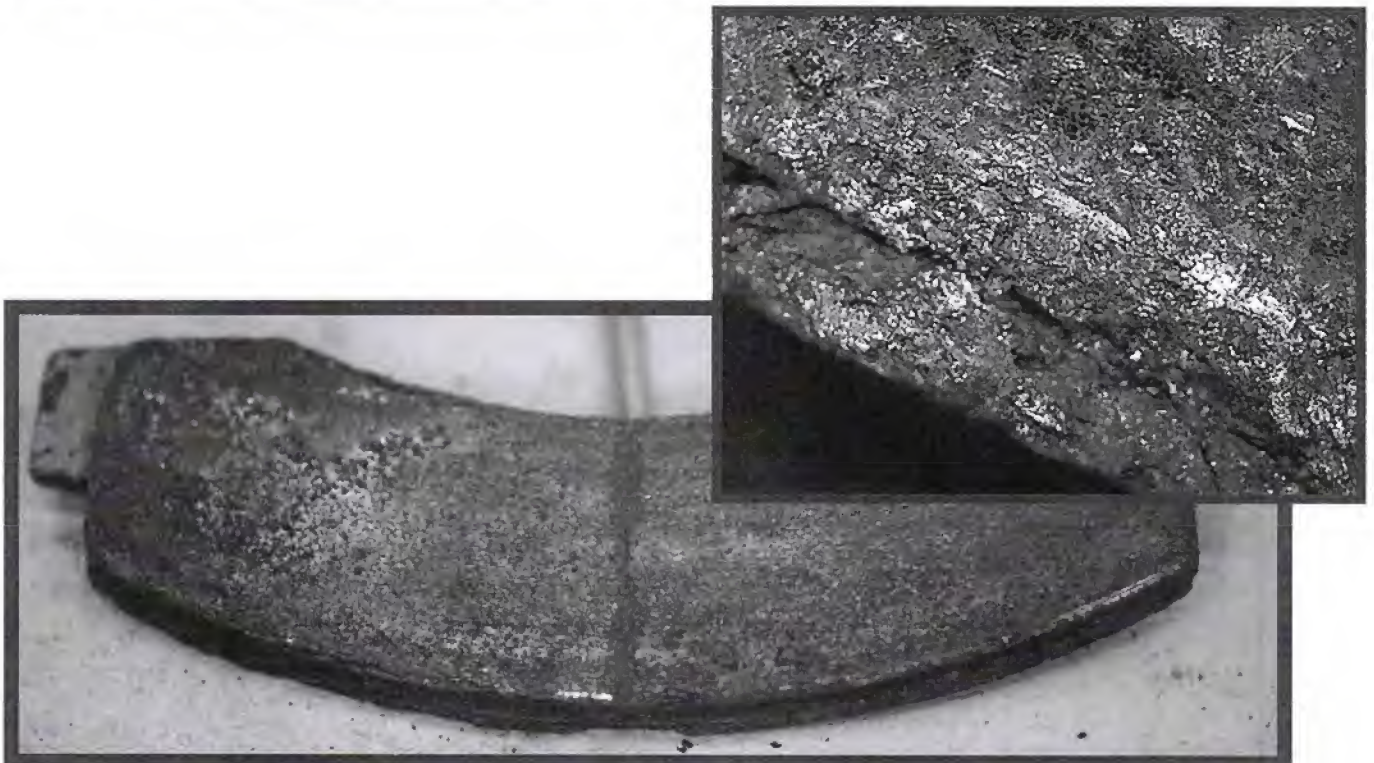
- ✓ Digital measurements of friction material thicknesses of outer disc brake pad 0.248" - 0.312", with tapered wear. Original friction material 0.443". Corrosion present at abutment clip locations.

- ✓ Digital measurements of friction material thicknesses of inner disc brake pad 0.210" - 0.281", with tapered wear. Original friction material 0.443". Corrosion present at abutment clip locations.

- ✓ Bonded design disc brake pads, semi-metallic composition.
- ✓ No brake dust detected due to prior extreme component temperatures.
- ✓ Obvious thermal distress noted, inclusive of embedded glazing deposits and obvious burnt material odor.

- ✓ Inner disc brake pad friction material exhibited embedded glazing deposits and corrosion, with onset of separation and delamination consistent with prior extreme friction temperatures.

Images No.34a & 34b. These photographs depict the outer disc brake pad friction material (above photograph, with insert) and the inner disc brake pad friction material (below photograph, with insert) of the left front disc brake pads of the 2001 Ford Excursion stretch limousine during the period of individual component analysis. The effects of severe thermal distress were clearly evident, including delamination and glazing.

Summary of Analysis, Left Front Brake System Components: *Pre-existing state was that of operational, albeit with reduced brake effort due to condition of disc brake pads and disc brake rotors from neglect of maintenance. Intense thermal distress from overwhelming braking friction resulted in disc brake pad friction material glazing, delamination, and separation. Brake dust accumulation clearly present at left front wheel location.*

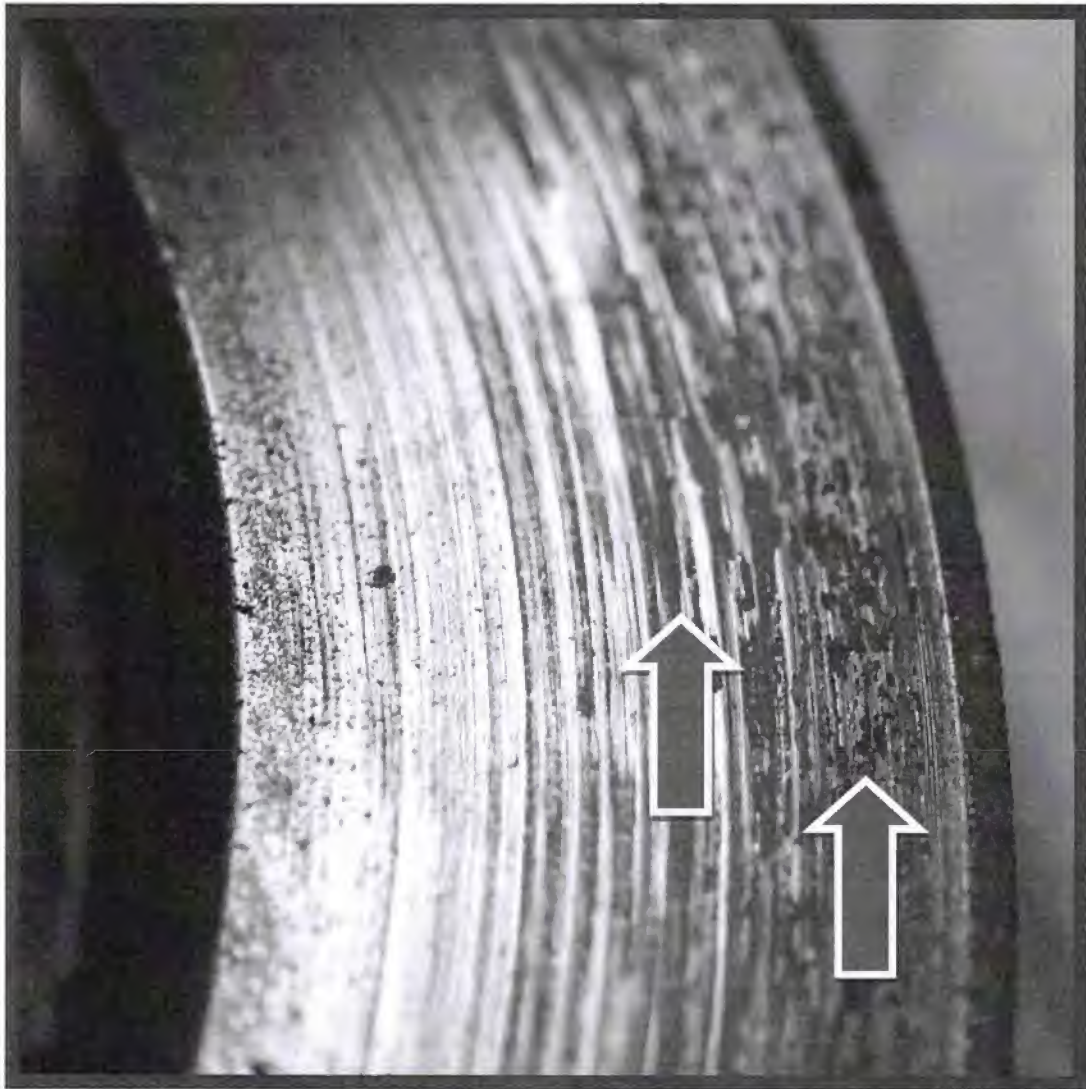
Image No.37. This photograph depicts the outer swept area of the right front disc brake rotor of the 2001 Ford Excursion stretch limousine during the period of individual component analysis. As with all front braking system components, the effects of severe thermal distress were clearly evident, including embedded material consistent with thermal deterioration of disc brake pad friction material during braking (Red Arrows).
